# Manhole Inspection Summary

Manhole # S21K1\_012MH

Insp Date: **4/25/08 8:49 AM**

**Location** Address: **2703 norland rd**

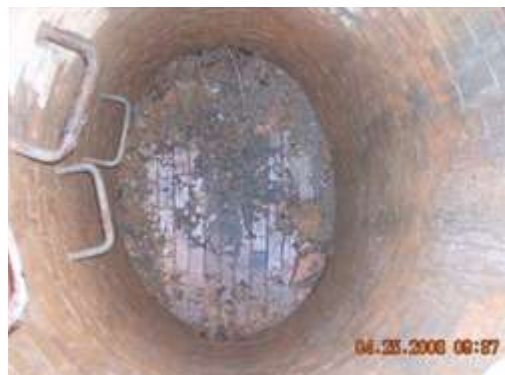
Top View

Comments **double out manhole with no bench. map 23k1 unavailable for the connecting node to the 6 oclock out.**

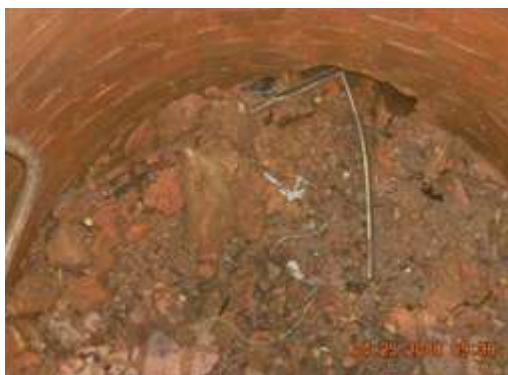
Defect 3

Condition: ☐ Sound ☐ Cracked ☐ Root Intrusion ☐ Deteriorated ☐ Leaks ☒ **Debris**

debris in channel @ 12 o'clock

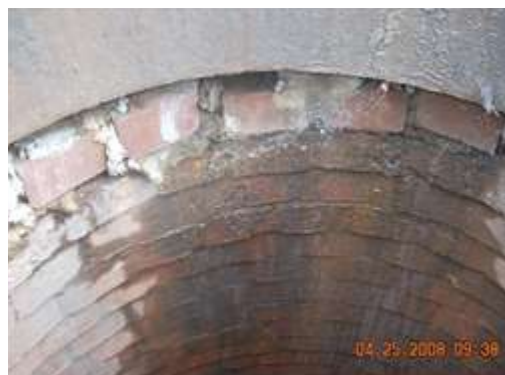
Defect 2

Condition: ☐ Sound ☐ Cracked ☐ Root Intrusion ☒ **Loose Brick** ☐ Deteriorated

Infiltration: ☐ None ☒ **Joint** ☐ Cracks ☐ Mortar ☐ Roots ☐ Wall

missing mortar, infiltration @ chimney/frame joint

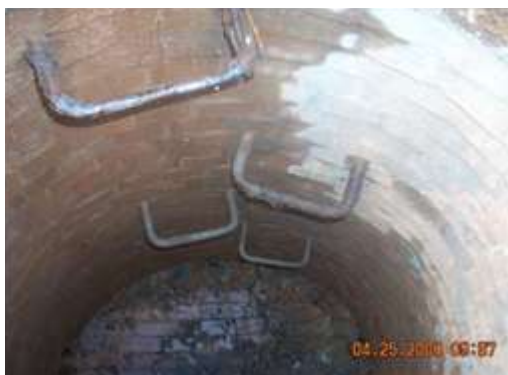
Defect 1

Count: **4** Missing: **0** ☒ **Corroded**

corroded steps

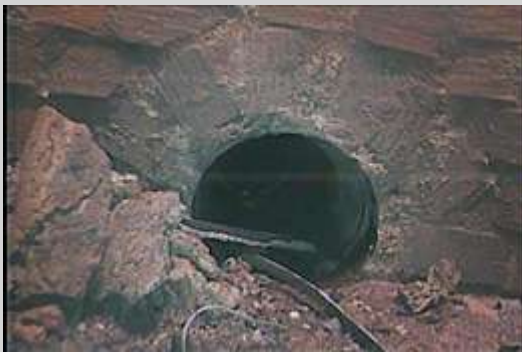
12 O'Clock Outflow

Pipe Height: **8.4** (in.) Rod and Bar (Angled)  
Pipe Material: **Clay** ☐ Pipe Lined  
Invert Depth: **7.99** (ft.) Flow Characteristics: **None**  
Deposits: ☐ None ☒ **Mud** ☐ Sludge ☒ **Debris** ☐ Grease  
Silt Depth: **2** (in.) Deposits Extent: **Light**  
Infiltration: **None** Pipe Seal Cond: **Sound**

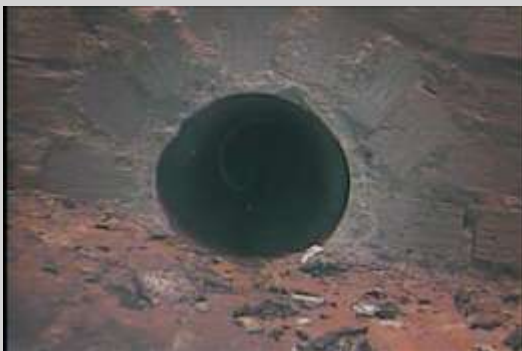
6 O'Clock Outflow

Pipe Height: **8.4** (in.) Rod and Bar (Angled)  
Pipe Material: **Clay** ☐ Pipe Lined  
Invert Depth: **7.98** (ft.) Flow Characteristics: **None**  
Deposits: ☒ None ☐ Mud ☐ Sludge ☐ Debris ☐ Grease  
Silt Depth: **0** (in.) Deposits Extent:  
Infiltration: **None** Pipe Seal Cond: **Sound**

Connects To: **Connecting Node Not Available**
